# **RUBBER TRACKS**

***TYPES OF DAMAGE  
DURING OPERATIONS***

## **BRIDGESTONE CORPORATION**

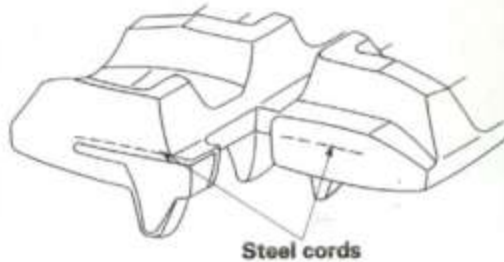
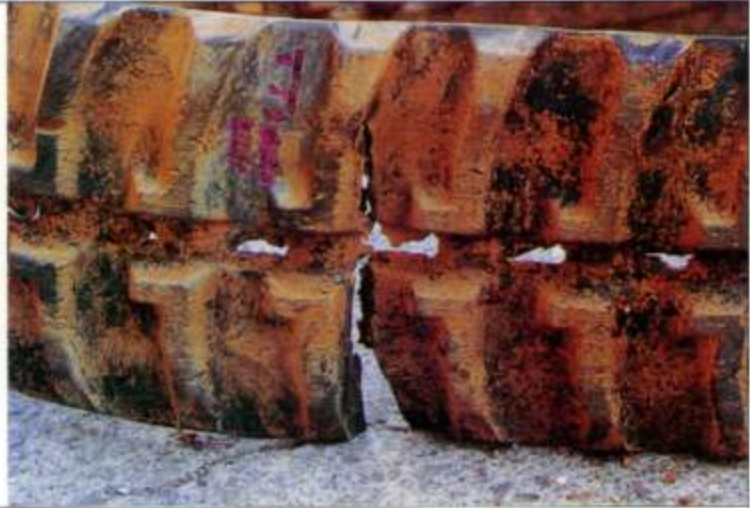
### (1) Cut of steel cords

Embedded steel cords are cut off

Replacement is required

When applied to rubber tracks under the following circumstances, tension in excess of the breaking strength of the embedded steel cords causes steel cords to be cut:

Furthermore, when moisture invades through a cut on the lug side rubber surface, the embedded steel cords will corrode. The deterioration of the design strength may lead to breaking off of the steel cords.

- (a) Periodical checking on site of the recommended tension level.
- (b) Avoiding quick turns on bumpy and rocky fields.
- (c) Making machine operators carefully drive as to avoid having stones and other articles clog to the rubber tracks.
- (d) Driving over sharp objects in the fields is to be avoided. If such is impossible, making turns while driving over such objects is to be avoided at the least.

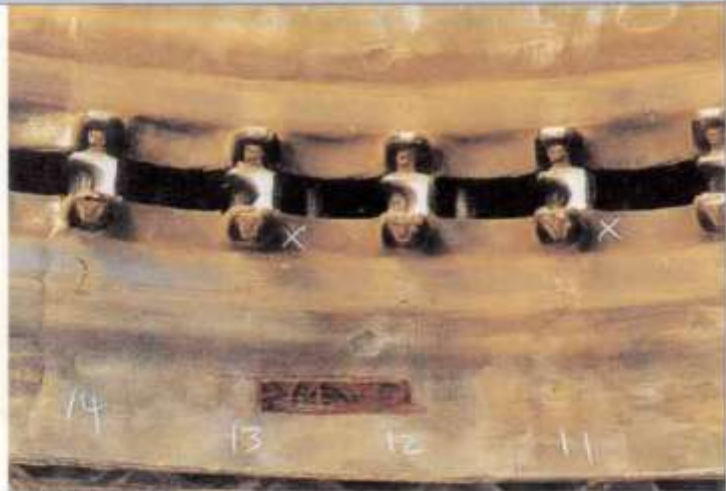
## (2) Abrasion of embedded metals

In proportion to the service time, embedded metals are gradually abraded.

Replacement is required when the width of the embedded metals ( $D_1$ ) becomes 67% of their original width ( $D$ ).

When track rollers roll over embedded metals, and sprocket and idler gears with them, abrasion of embedded metals is inevitable. The following cases sometimes accelerate their abrasion:

- Sprocket configuration does not correspond with the design of the embedded metals.
- Rubber tracks are driven with an extraordinary heavy load on them.
- Rubber tracks are used on sandy fields.

As long as rubber tracks are used under normal operating conditions, abnormal abrasion is unlikely to occur. The level of abrasion should be carefully checked when the machines are mainly operated for towing and dozing works which generate a heavy load for rubber tracks, and when they are operated under a sandy field condition for a long time.

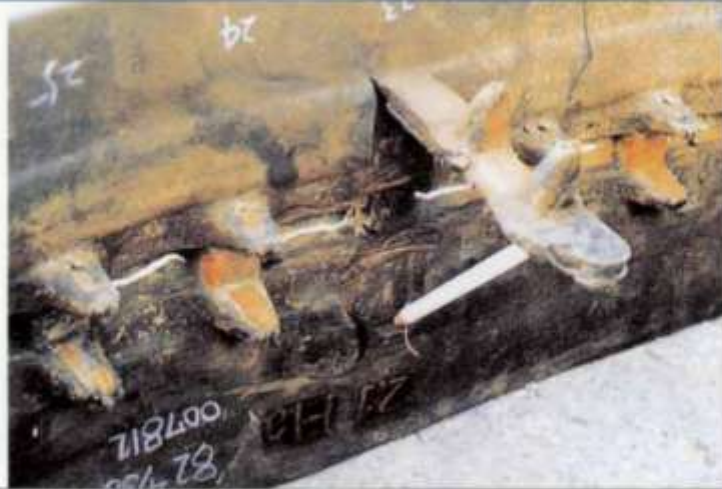
### (3) Separation of embedded metals due to external forces

Extraordinary outer forces applied to embedded metals cause their separation from the rubber track's body.

Even a partial separation of embedded metals requires replacement of the complete track.

Embedded metals are adhered between the steel cords and the rubber body. The following cases generate external forces greater than the adhesion strength, causing separation of the embedded metals.

- (a) Recommended tension level should be periodically maintained.  
(b) Quick turns on bumpy and rocky fields should be avoided.  
(c) If abnormal abrasion of sprockets is observed, they should be immediately replaced.

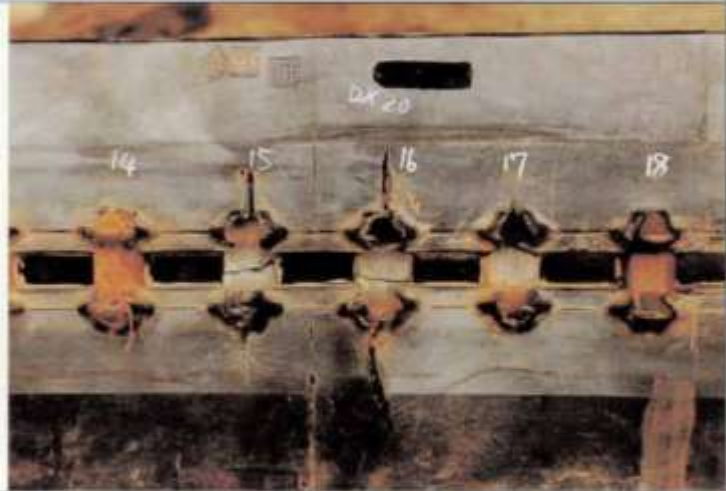
#### (4) Separation of embedded metals due to corrosion

Due to corrosion of embedded metals, the adhesion to the rubber body deteriorates, resulting in complete separation.

Even a partial separation of embedded metals requires a complete rubber track replacement.

Embedded metals are adhered to the rubber body. The following operating conditions cause embedded metals to corrode, causing deterioration of the adhesion, and finally resulting in separation of the embedded metals from the rubber body :

- (a) Excessively salty fields, like the sea shore
- (b) Strongly acidic or alkali containing terrains
- (c) Compost spread grounds

In case of an outside running arrangement track rollers gradually abrade the rubber surface at track roller side, ending in exposure of the embedded metals. Consequently the embedded metals will corrode resulting in their separation from the rubber body.

If rubber tracks are used under such field conditions as described under A-(a) (b) (c), they should be washed with plenty of water. After being completely dried, they should be stored properly.

When the cover rubber is separated from the embedded the metal projections and the metals in the rubber body become loose, it is time to consider replacement of the rubber track.

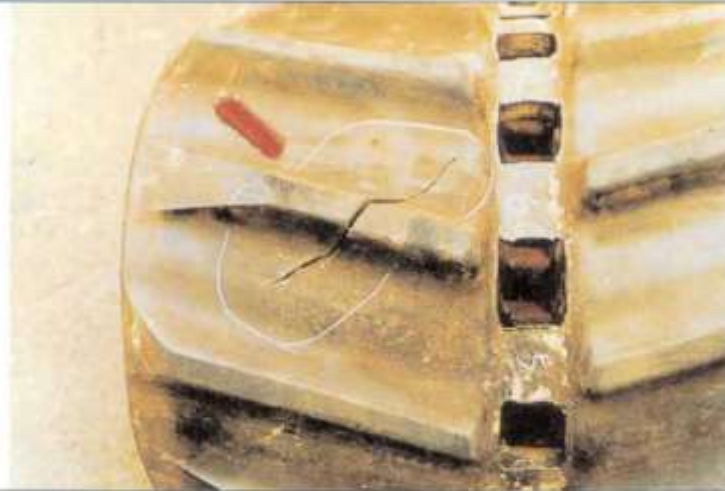
## (5) Cut on lug side rubber

Cut on lug side rubber often occurs as one of the most typical failure modes.

When rubber tracks drive over projections or sharp stones in the fields, the concentrated forces applied cause cuts on the lug side rubber surface. In case of making turns on projections, the lug side rubber surface will have an even higher chance to be cut. If the cuts run through the embedded steel cords, it might result in the steel cords breakage due to their corrosion. It is highly recommended to repair the cuts with cold vulcanization rubber as soon as they are observed.

When a cut on the lug side rubber reaches the embedded steel cords, it should be immediately repaired in accordance with our repair manual.

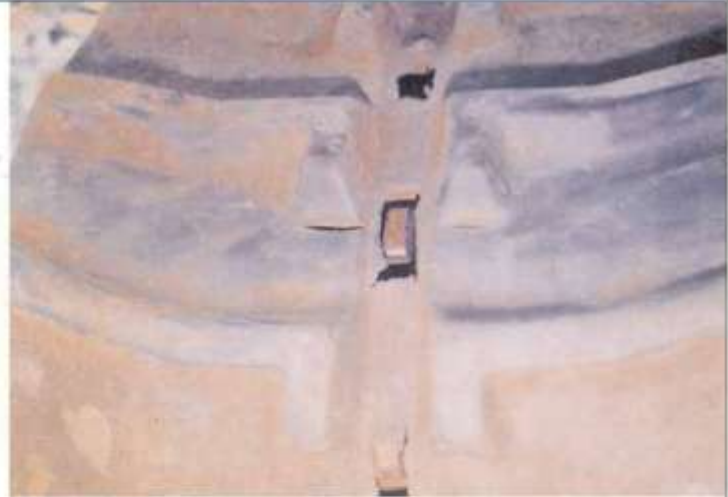
Fatigue crack

Small cracks around the root of the lug as a result from operation fatigue.

When the cracks reach so deep that they expose the steel cords, whole track replacement is required.

Because of wound stress applied to rubber tracks around the undercarriage parts during operation, the fatigue especially causes cracks on the lug side rubber surface. Once the cracks occur, they gradually deteriorate with even small external injuries.

Rubber tracks are designed with special rubber compounds as to prevent cracks due to fatigue. However, external injuries on the lug side rubber sometimes cause more chance of cracking. Machine operators should take good care when driving, so as not to cause external injuries to the lug side rubber. In order to minimize the occurrence of ozone cracks, attention should be paid to the following instructions for maintenance:

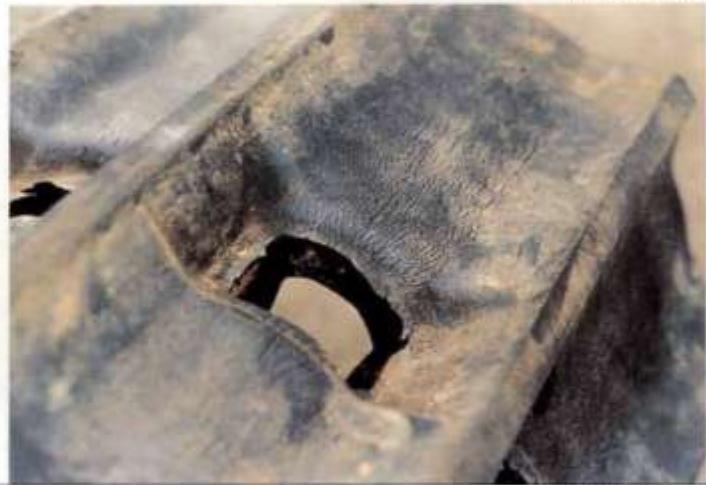
Ozone crack

Also when operating near seashores or under cold temperatures, rubber tracks are more likely to suffer from ozone cracks.

- \* Avoid exposing stored tracks to direct sun light
- \* Avoid exposing stored tracks to direct rain and snow fall
- \* Store tracks in well ventilated warehouses
- \* Use the tracks at least once a month

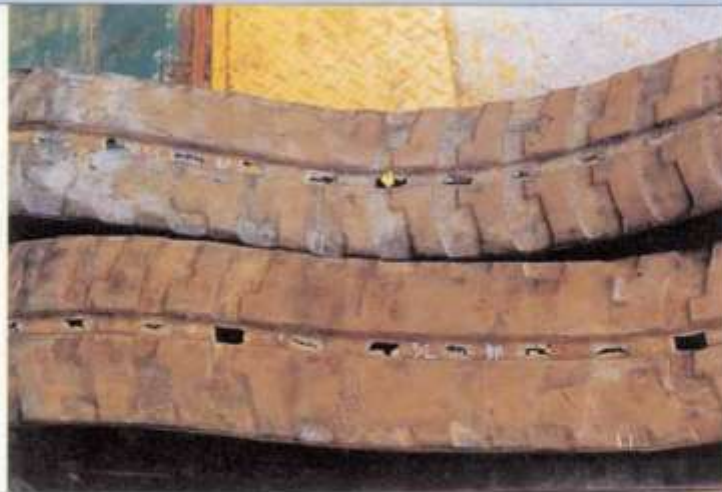
## (7) Lug abrasion

As its service time proceeds, the lug side inevitably undergoes abrasion.

No replacement is required.

Lug abrasion is more or less inevitable. Even if lug abrasion is proceeding, the rubber track can be used. However, as the traction performance deteriorates accordingly, it is highly recommended to replace the abraded tracks with new ones when the lug height becomes less than 5 mm.

- \* Making quick and repeated turns on concrete and asphalt roads
- \* Driving up and down mountain paths with slippage
- \* Making frequent turns on paths covered with rocks and wood

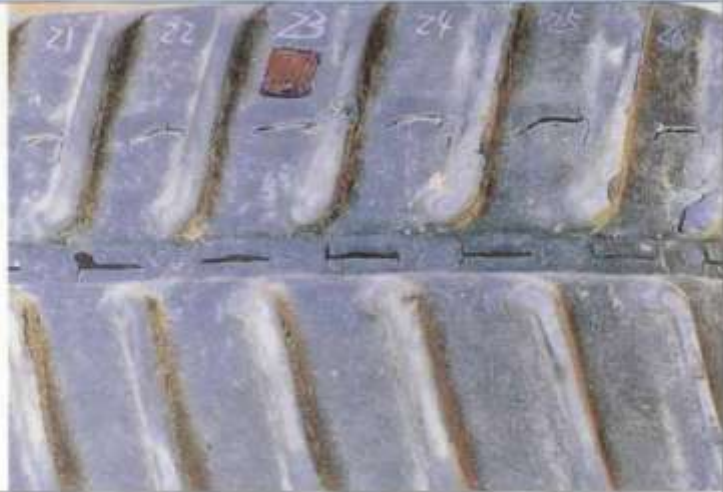
## (8) Cracks and cuts on the lug side rubber at the edges of the embedded metals

Sometimes cracks and cuts on the lug side rubber at the edges of the embedded metals can be observed.

Basically, no replacement is required unless the cuts on the lug side rubber are discovered all around the edges of the embedded metals, as this will result a complete cut off.

When rubber tracks drive over sharp projections, intensive stress is applied to the lug side rubber surface, especially at the edges of embedded metals, causing cracks and cuts in the area around the embedded metals.

To avoid intensive stress applied to the lug root where metals are embedded, machine operators are requested to avoid driving over stumps and ridges.

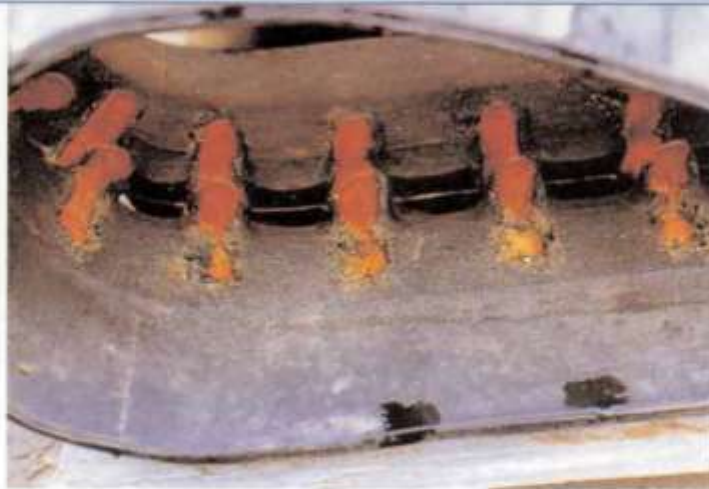
## (9) Abrasion of the track roller side rubber surface

The rubber surface on which track rollers run is gradually abraded. It will end in the exposure of the embedded metals.

It is recommended to replace the rubber track when more than half of the embedded metals are completely exposed.

The abrasion of the track roller side rubber surface occurs because of sand and gravel being clogged between the rubber and the outside running track rollers. The stress pushes such sand and gravel to the inner side of the rubber track to cause the abrasion in the end.

The level of abrasion is highly dependent on terrain conditions. A higher level of abrasion will occur when the rubber tracks are operated at fields covered with many stones and gravel. Small stones hardened with mud, stuck to the track rollers increase the abrasion level. After an extended period of abrasion, it will be more likely for exposed embedded metals to catch moisture through the inside steel cords, which can cause breakage of steel cords and separation of the metals from the rubber body.

After operation in wet fields containing many small stones, please wash off the mud that is stuck to the track rollers completely. When operating on gravel paths and stony grounds, machines should be driven slowly and the turning radius should be big enough to prevent stones and gravel from getting stuck to the track roller side rubber.

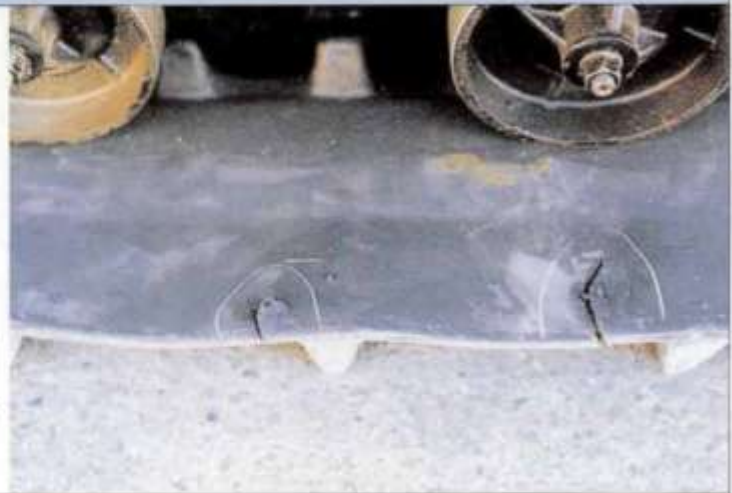
## (10) Cuts on the edges of track roller side rubber

Both edges of rubber track have no special reinforcements. It sometimes occurs during operation they are cut or torn off.

In such case, the rubber track does not have to be replaced.

This damage is caused by objects on the field or by interference with the machine frame :

The edges of rubber track are often deformed largely due to a bumpy ground surface, stones and other objects, which cause intensive stress on the edges resulting in the damage. Especially, when a machine drives over concrete ridges, this type of damage easily occurs.

If a machine continues operating with rubber tracks being detracked, the rubber tracks may get caught up in the machine frame or undercarriage parts resulting in damage. Furthermore, when a machine travels along side slopes, the rubber tracks are deformed so much that they come into contact with the machine frame and undercarriage parts, which causes cutting, gouging and rubbing of rubber tracks in the end.

When travelling, a machine operator should be careful not to drive over any projections on the ground. He should also prevent rubber tracks from coming into contact with concrete walls, ditches and ridges. If rubber tracks are detracked, the machine should be stopped immediately for retracking.
