## SPEED SENSING OPTION TROUBLESHOOTING

## MODEL # 8625

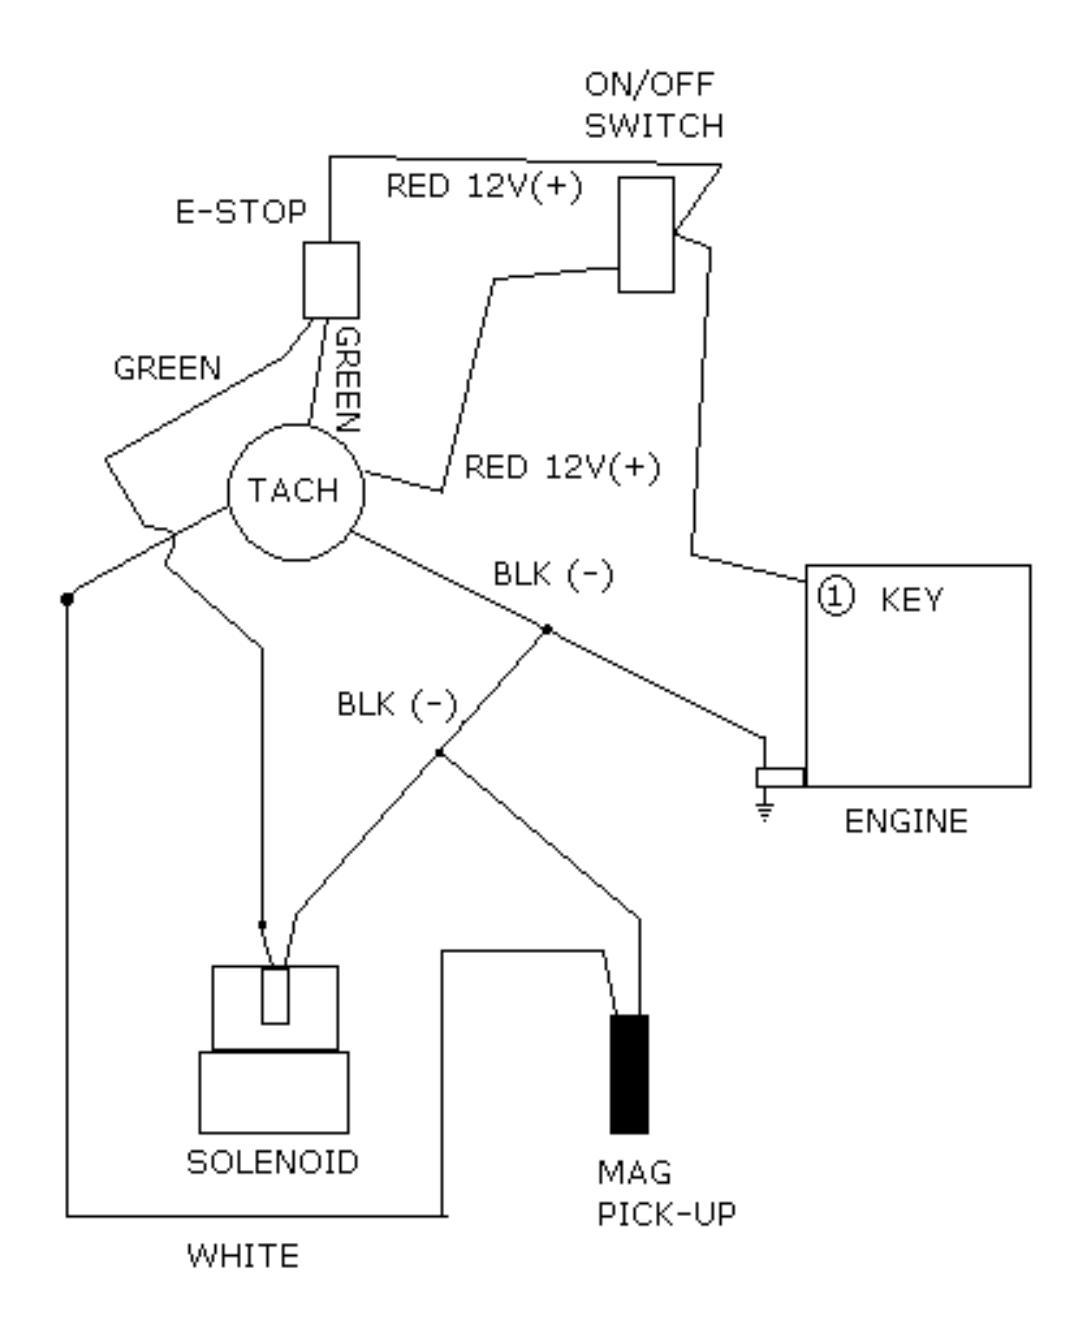
Typical Wiring Diagram:

If all things appear to be operating normally and feed has not been established, run unit at full throttle and using a test light, locate and test the green wire leading from the tach box to the solenoid for voltage. Voltage should not be present. If it is, remove tach box and check condition of e-stop switch. For safety reasons, the e-stop switch is 12V hot through key power. If the switch has failed power will pass through to the green wire energizing the solenoid constantly.
