# **RUBBER TRACKS**

***TYPES OF DAMAGE  
DURING OPERATIONS***

## **BRIDGESTONE CORPORATION**

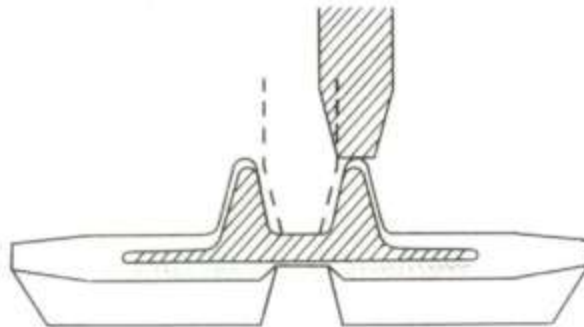
When applied to rubber tracks under the following circumstances, tension in excess of the breaking strength of the embedded steel cords causes steel cords to be cut:

- (a) When the rubber track is detracking, the idler or sprocket rides on the projections of the embedded metal. (see the sketch below)

- (a) Periodical checking on site of the recommended tension level.
- (b) Avoiding quick turns on bumpy and rocky fields.
- (c) Making machine operators carefully drive as to avoid having stones and other articles clog to the rubber tracks.
- (d) Driving over sharp objects in the fields is to be avoided. If such is impossible, making turns while driving over such objects is to be avoided at the least.

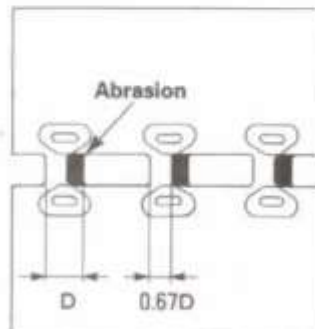
When track rollers roll over embedded metals, and sprocket and idler gears with them, abrasion of embedded metals is inevitable. The following cases sometimes accelerate their abrasion:

- Sprocket configuration does not correspond with the design of the embedded metals.
- Rubber tracks are driven with an extraordinary heavy load on them.
- Rubber tracks are used on sandy fields.

As long as rubber tracks are used under normal operating conditions, abnormal abrasion is unlikely to occur. The level of abrasion should be carefully checked when the machines are mainly operated for towing and dozing works which generate a heavy load for rubber tracks, and when they are operated under a sandy field condition for a long time.

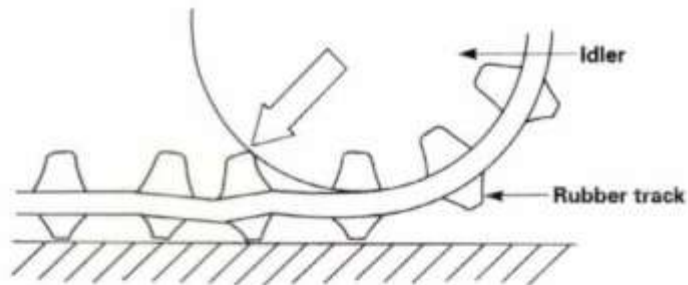
Embedded metals are adhered between the steel cords and the rubber body. The following cases generate external forces greater than the adhesion strength, causing separation of the embedded metals.

- (a) When the idler continues riding on projections of embedded metals, embedded metals might peel off finally.

- (a) Recommended tension level should be periodically maintained.  
(b) Quick turns on bumpy and rocky fields should be avoided.  
(c) If abnormal abrasion of sprockets is observed, they should be immediately replaced.

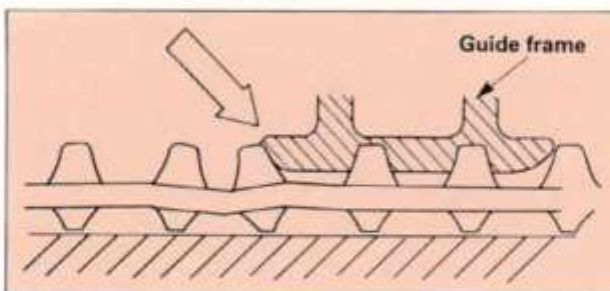
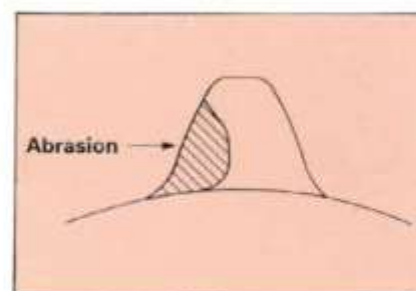
- (b) When a rubber track is detracked, it becomes stuck between the guide frame or the undercarriage frame, causing the separation of embedded metals.

- (c) Abnormally abraded sprockets as sketched above will pull embedded metals out.

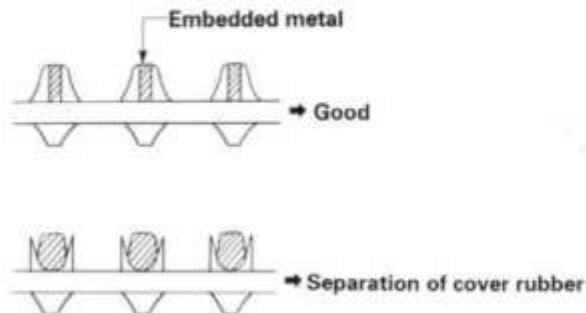
In case of an outside running arrangement track rollers gradually abrade the rubber surface at track roller side, ending in exposure of the embedded metals. Consequently the embedded metals will corrode resulting in their separation from the rubber body.

When the cover rubber is separated from the embedded the metal projections and the metals in the rubber body become loose, it is time to consider replacement of the rubber track.

If rubber tracks are used under such field conditions as described under A-(a) (b) (c), they should be washed with plenty of water. After being completely dried, they should be stored properly.

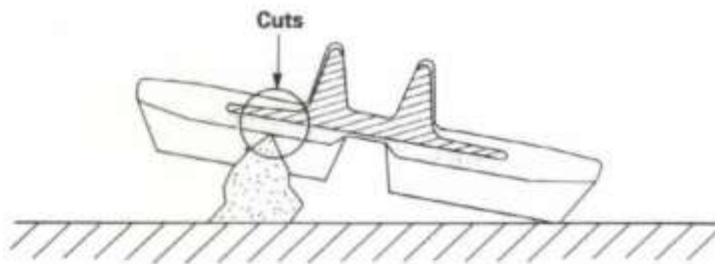
When rubber tracks drive over projections or sharp stones in the fields, the concentrated forces applied cause cuts on the lug side rubber surface. In case of making turns on projections, the lug side rubber surface will have an even higher chance to be cut. If the cuts run through the embedded steel cords, it might result in the steel cords breakage due to their corrosion. It is highly recommended to repair the cuts with cold vulcanization rubber as soon as they are observed.

When operating on terrains as mentioned above, high speed drive, quick turns and overloadings should be avoided.

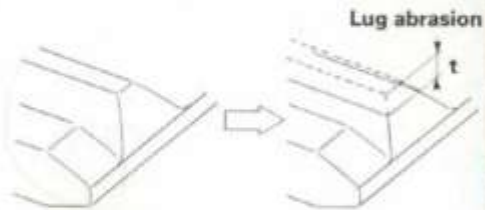
Lug abrasion is more or less inevitable. Even if lug abrasion is proceeding, the rubber track can be used. However, as the traction performance deteriorates accordingly, it is highly recommended to replace the abraded tracks with new ones when the lug height becomes less than 5 mm.

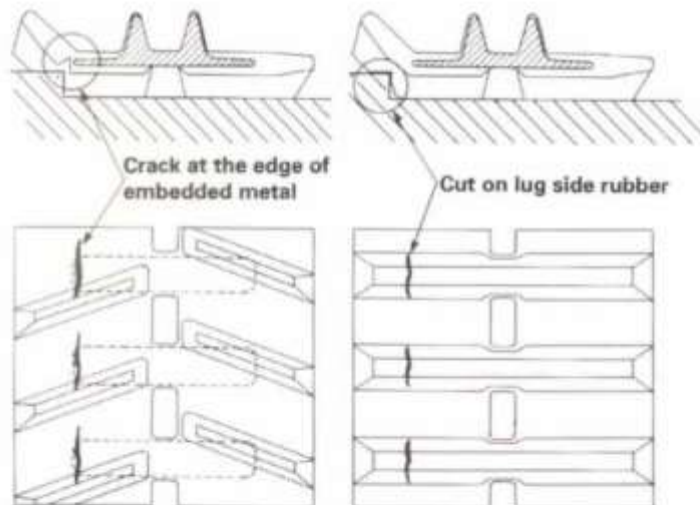
When rubber tracks drive over sharp projections, intensive stress is applied to the lug side rubber surface, especially at the edges of embedded metals, causing cracks and cuts in the area around the embedded metals.

To avoid intensive stress applied to the lug root where metals are embedded, machine operators are requested to avoid driving over stumps and ridges.

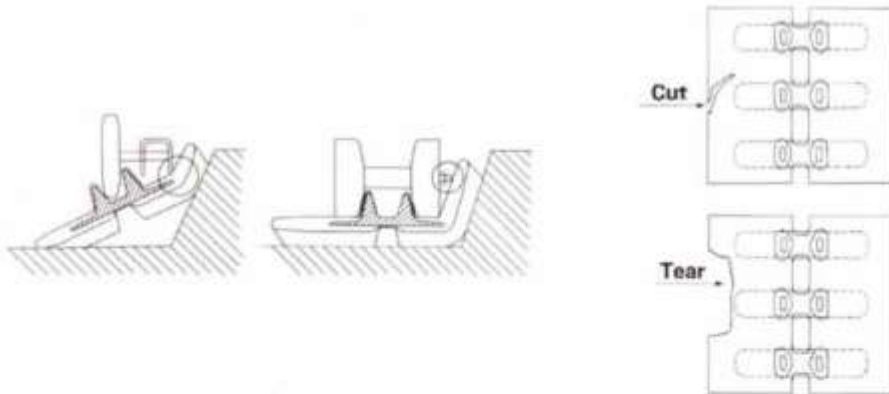
The edges of rubber track are often deformed largely due to a bumpy ground surface, stones and other objects, which cause intensive stress on the edges resulting in the damage. Especially, when a machine drives over concrete ridges, this type of damage easily occurs.
